Performance of housing in Brisbane following storms on 16 November 2008 *

C Leitch[†] and J Ginger

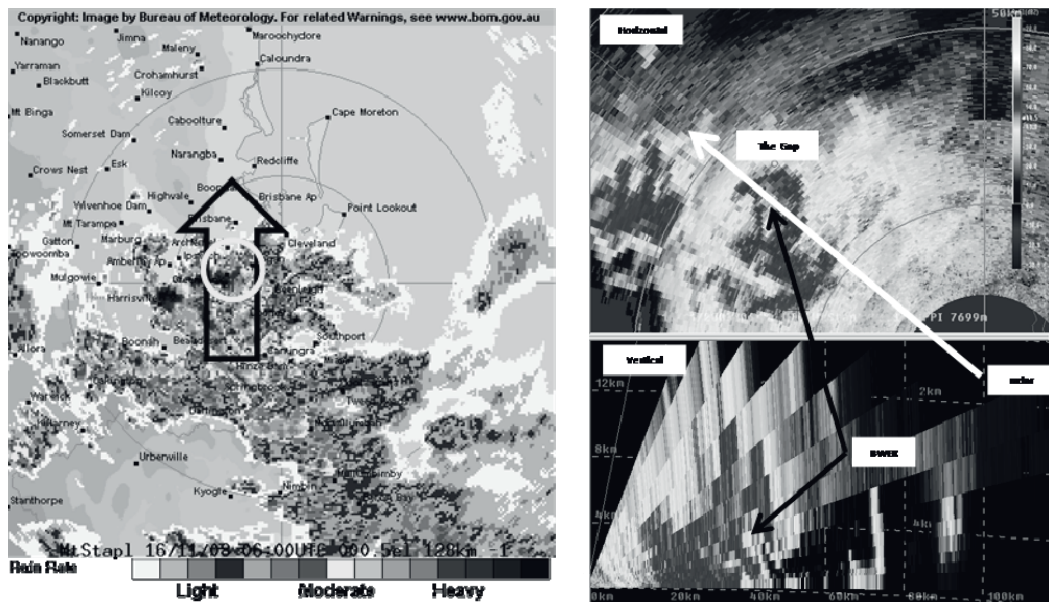
Figure 2: Bureau of Meteorology radar imagery of hydrometeor reflectivity on 16 November 2009 from Mt Stapylton radar. Left: Regional plan view at 0600 UTC centred on the radar showing 50 km range rings; circle indicates The Gap cell and arrow indicates approximate direction of motion. Right: Composite of detailed horizontal and vertical scans from the radar at 0624 UTC towards The Gap location (vertical scan has radar origin lower left).

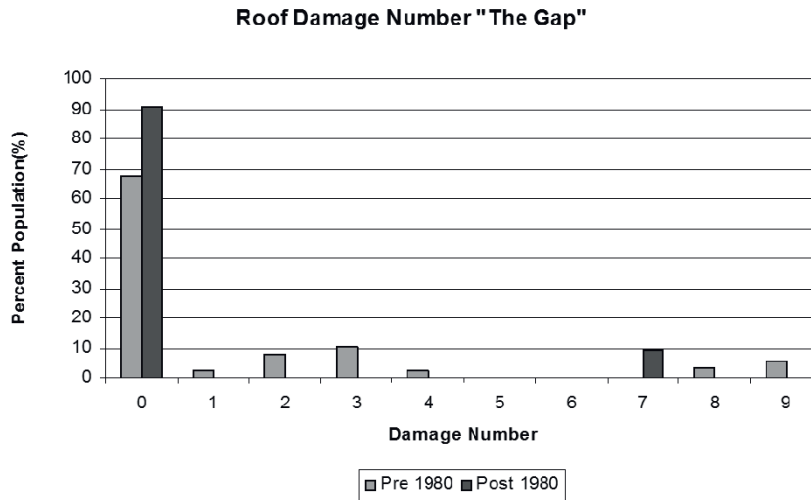
Figure 4: Percentage of houses versus roof Damage Number.

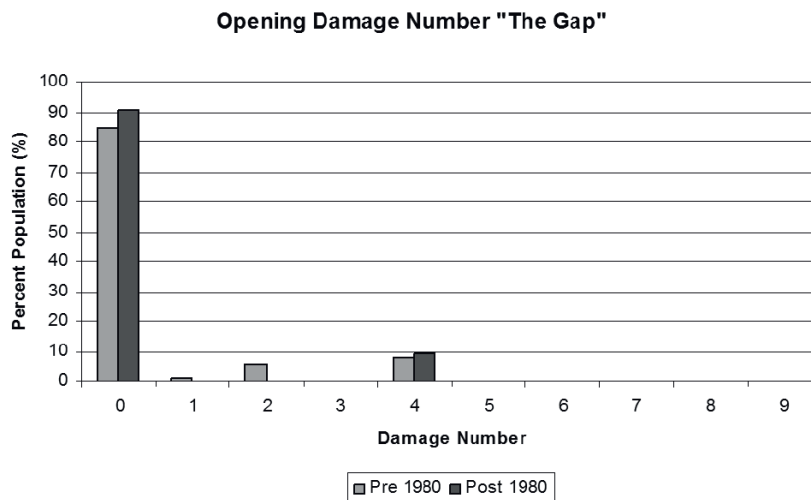
Figure 5: Percentage of houses versus openings Damage Number.

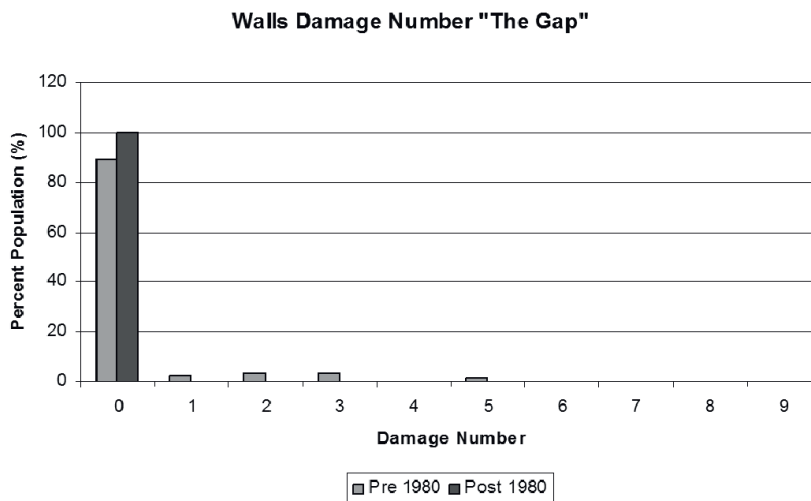
Figure 6: Percentage of houses versus wall Damage Number.

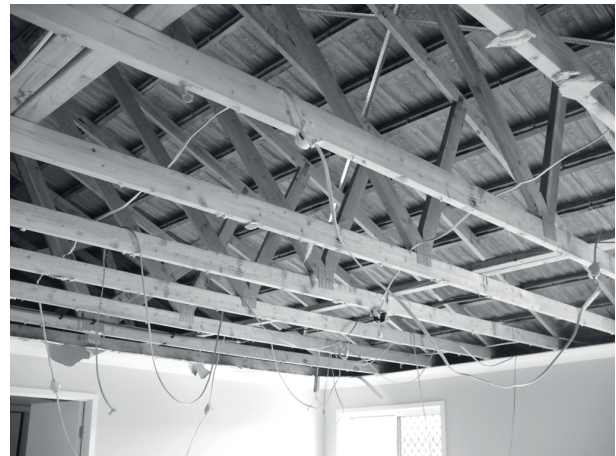
Figure 8: General view of typical ceiling collapse (unsarked tile roof).

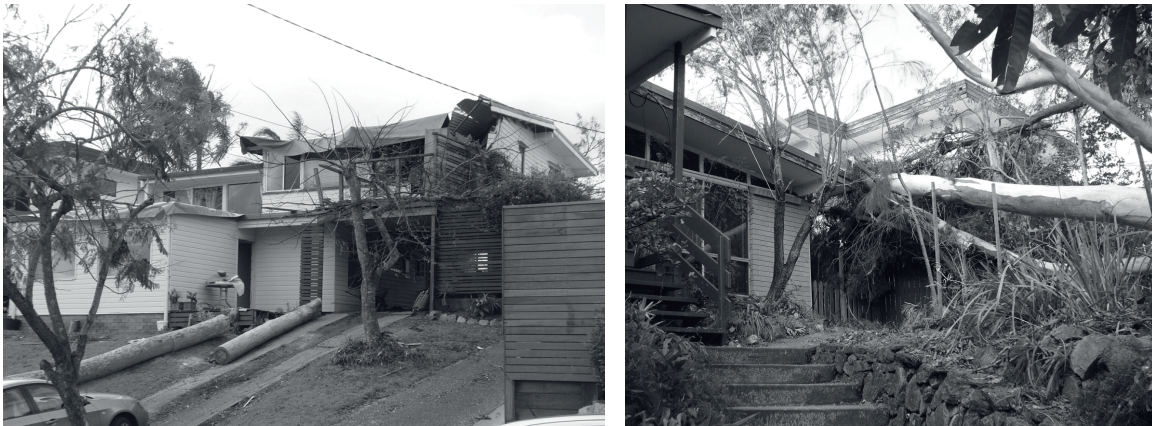
Figure 10: Damage to housing caused by large falling trees in The Gap.

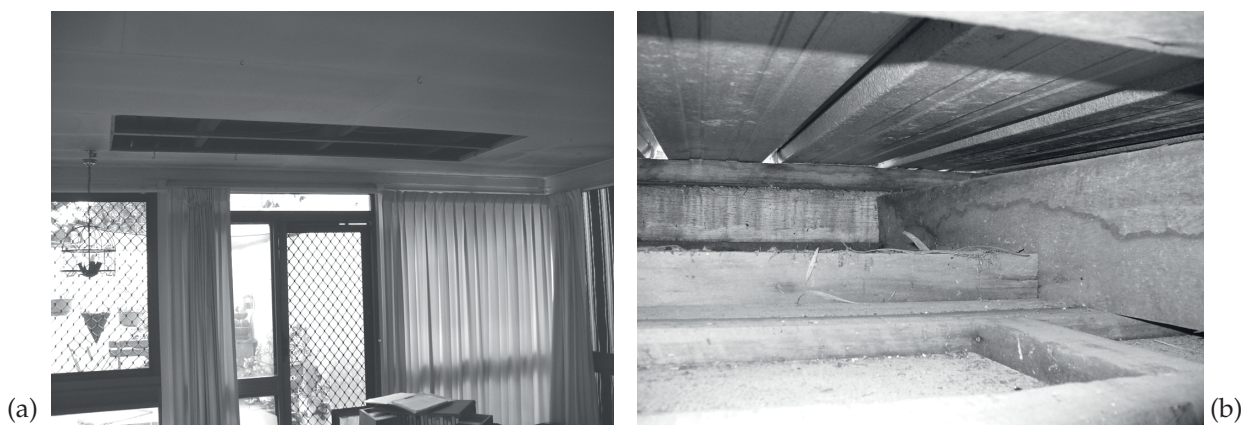
Figure 11: Overflow of gutter water into ceiling space – (a) view of hole in ceiling, after collapse of one plasterboard panel; and (b) view inside ceiling space showing water staining on rafter overhang.

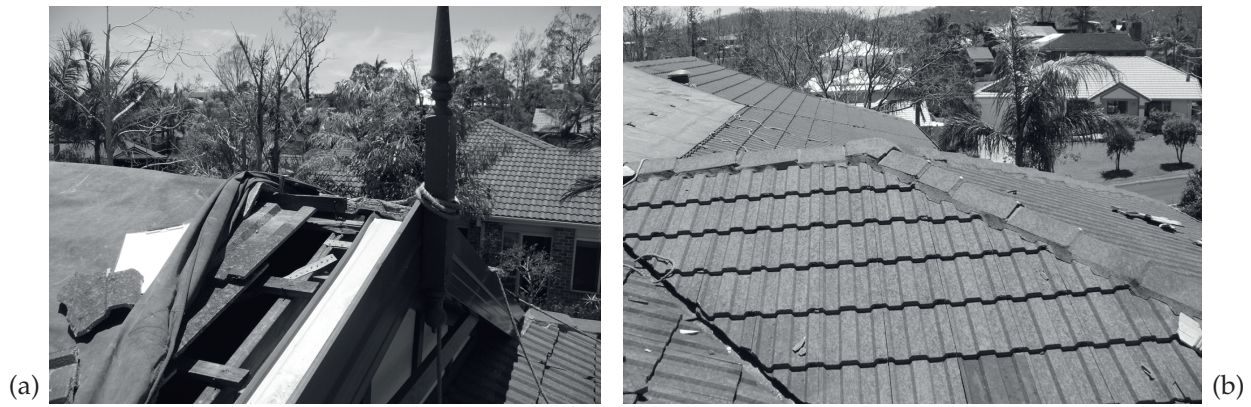
Figure 12: Details of ridge tile roof failure and hip tiles without mechanical fastening – (a) view of failed ridge tiles under tarpaulin; and (b) view of ridge and hip tiles, which are still in place but some without mechanical fasteners.

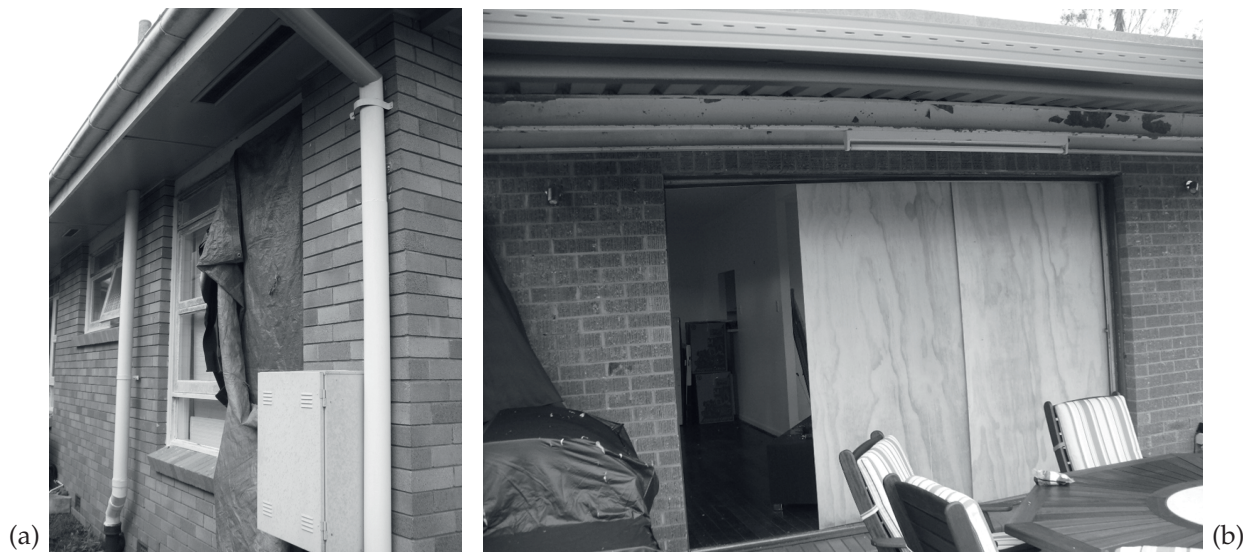
Figure 13: Typical windows and doors failure – (a) hail damage and window pushed in; and (b) sliding door failed.

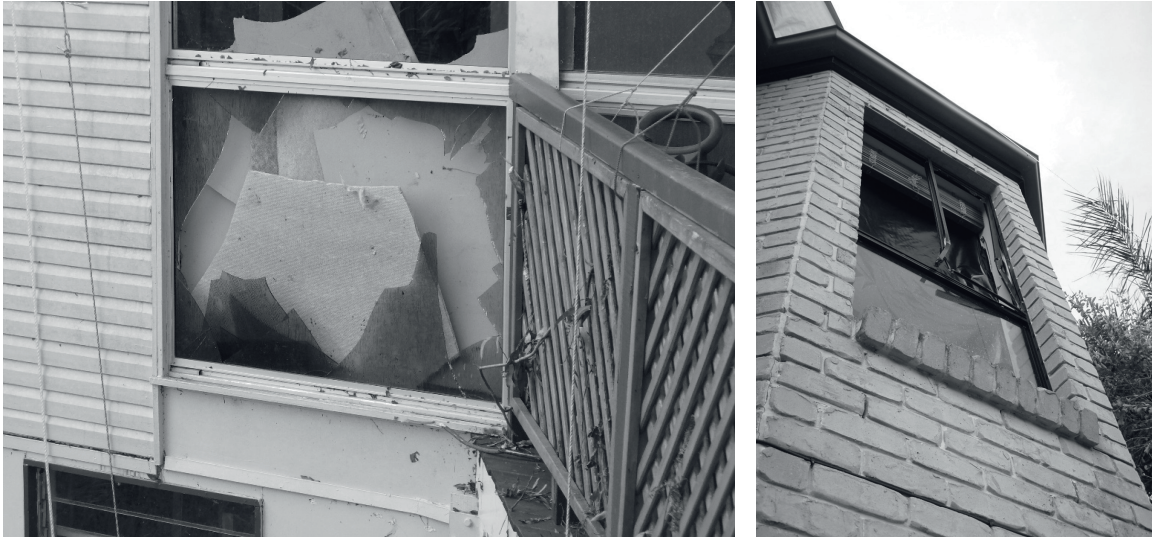
Figure 14: Typical wind-borne debris damage to windows.

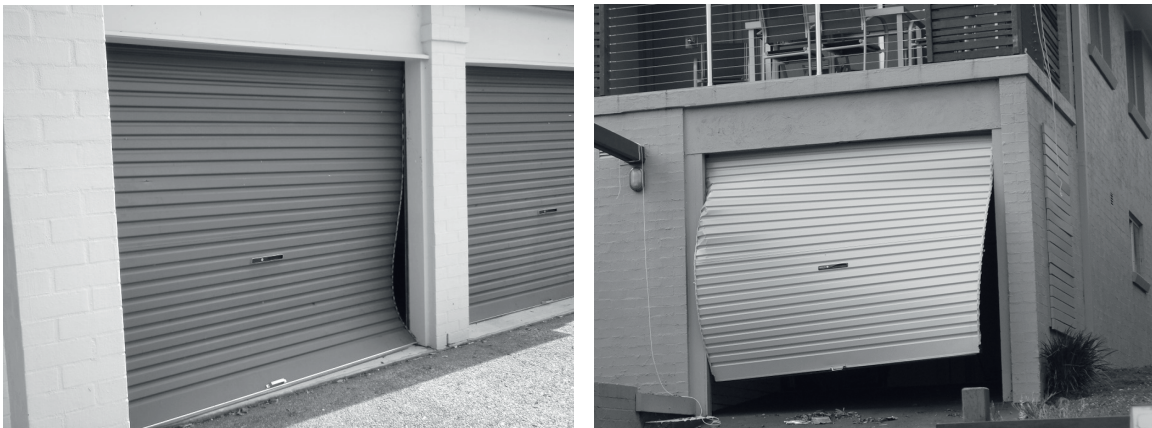
Figure 15: Typical roller door failures.

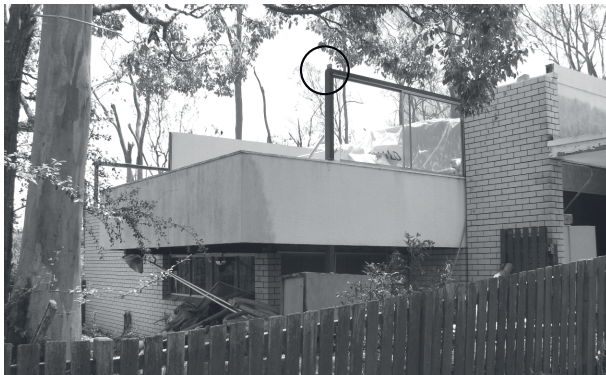
Figure 16: General view of front of house without roof.

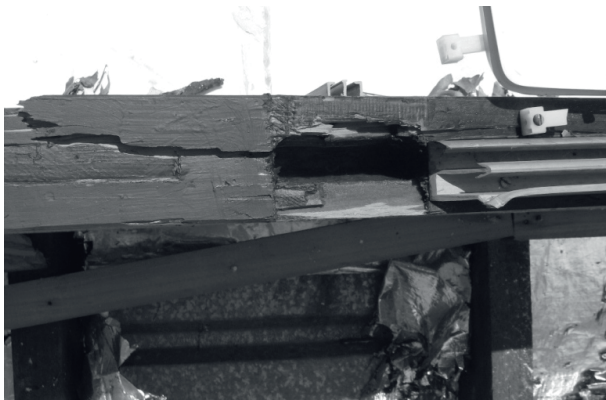
Figure 18: Typical view of a failed mortice joint to roof beam.

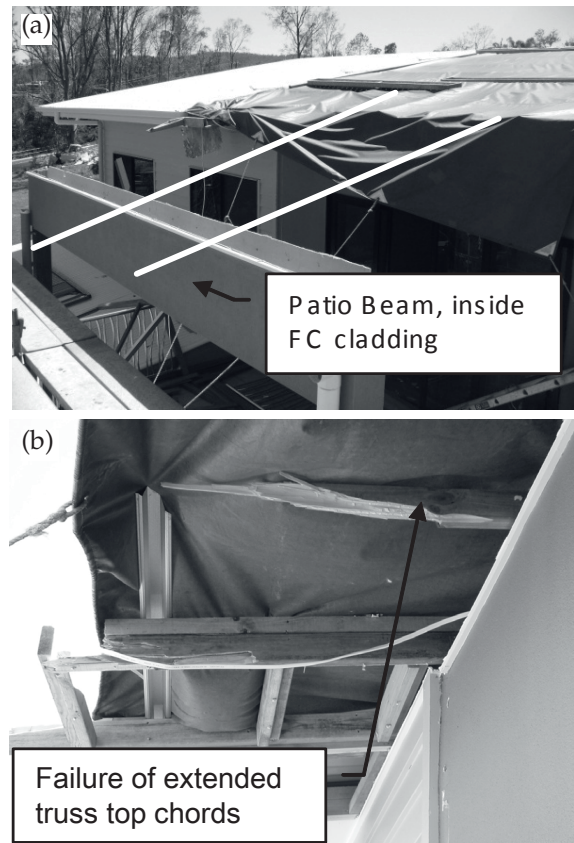
Figure 19: Failed patio roof structure – (a) general view showing extent of the loss of the patio roof; and (b) view from underneath patio roof showing failed truss tails.

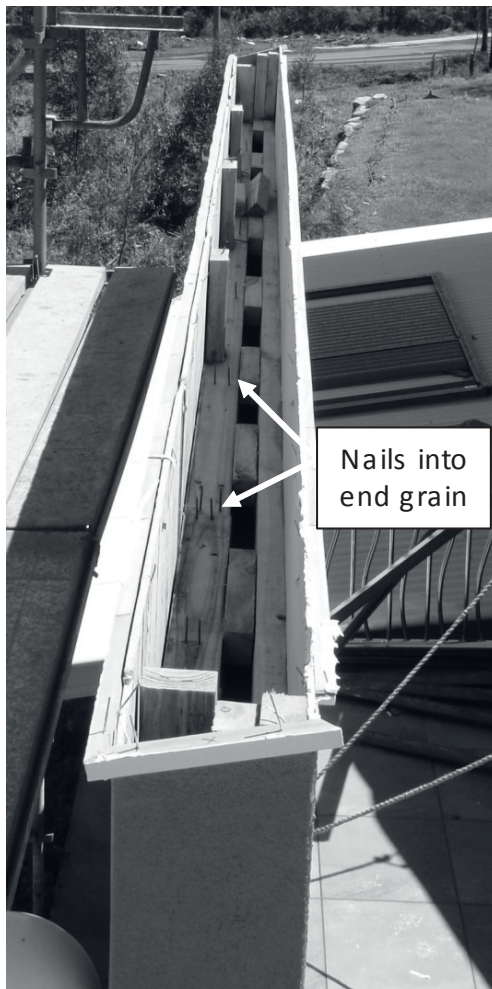
Figure 20: Detailed view inside FC cladding to patio beam showing failure of nailed joints to jack studs.

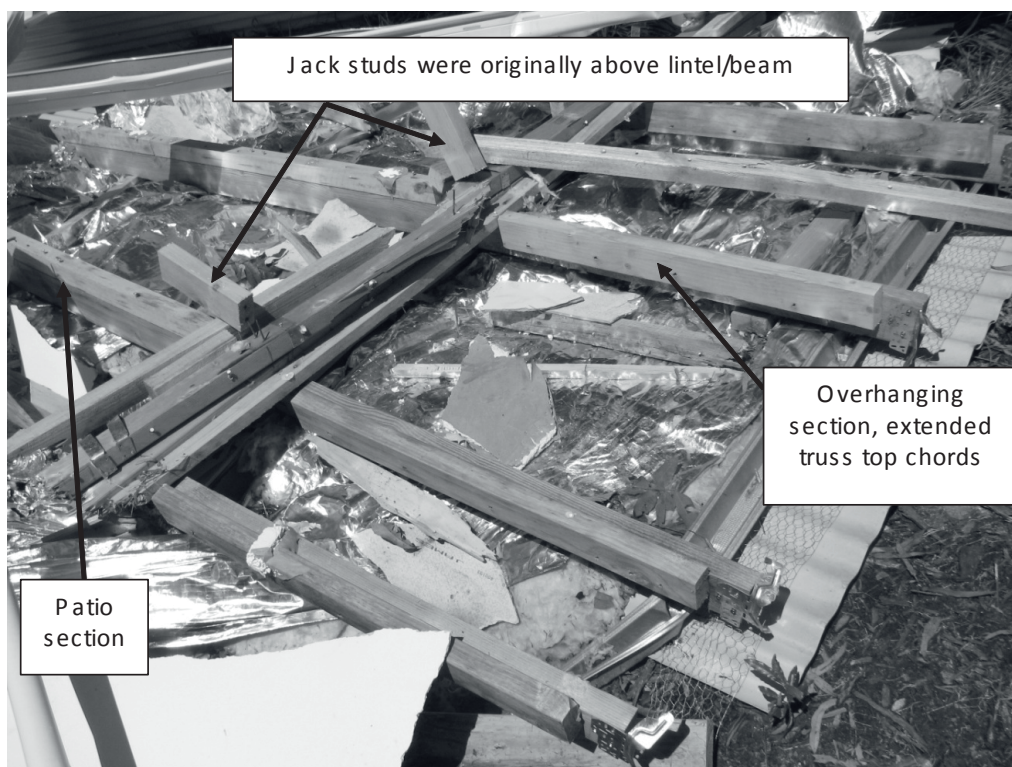
Figure 21: Failed patio roof structure about 200 m downwind from house.

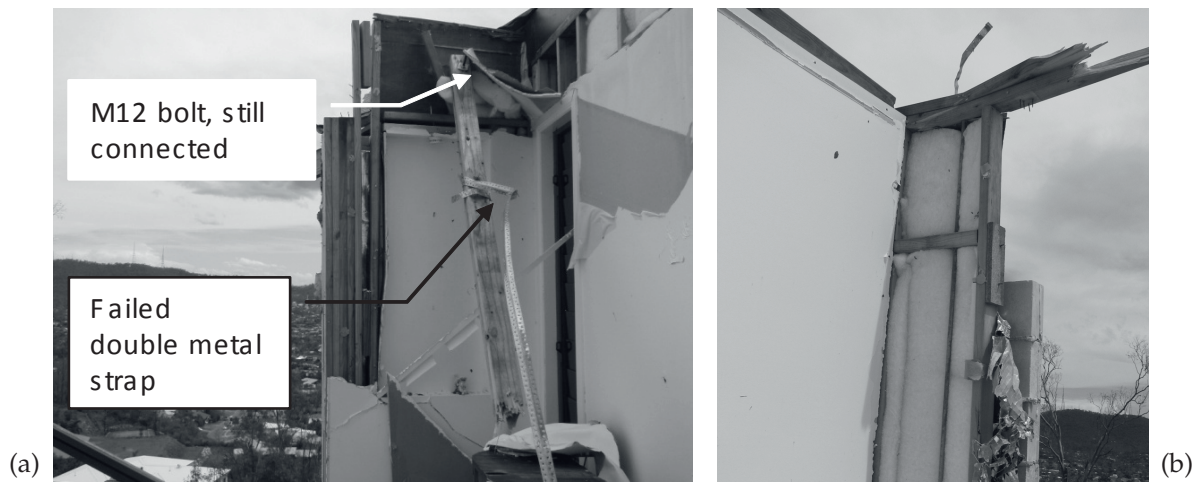
Figure 22: Lintel hold-down, combination of metal straps and HD bolts at far end of ply bracing frame – (a) one end of top plate, strap failed and M12 bolt too far away; and (b) M16 bolt too far from lintel and not configured as per AS1684.

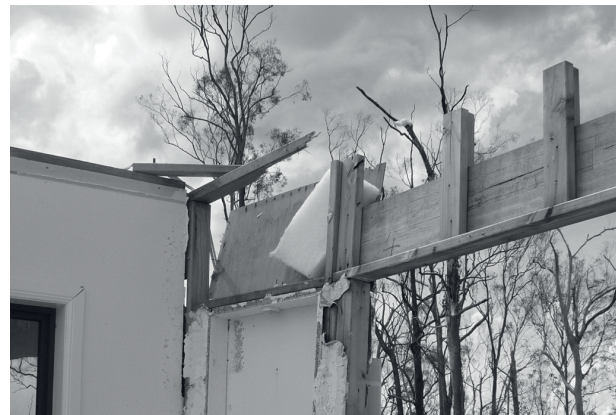
Figure 23: Lintel to back window, held down by ply bracing panel.

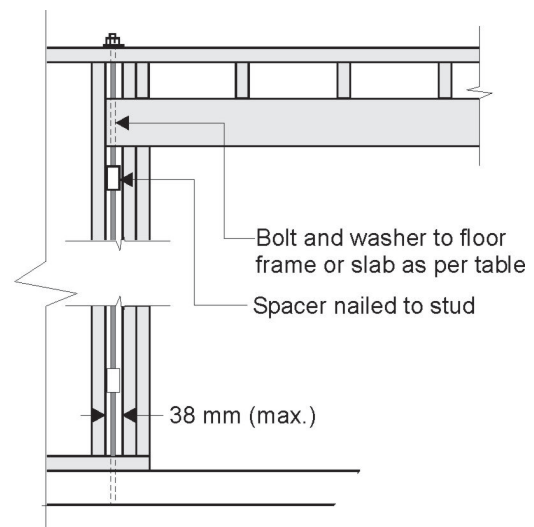
Figure 24: One method for lintel tie-down using M16 rods (as specified in AS1684.2).

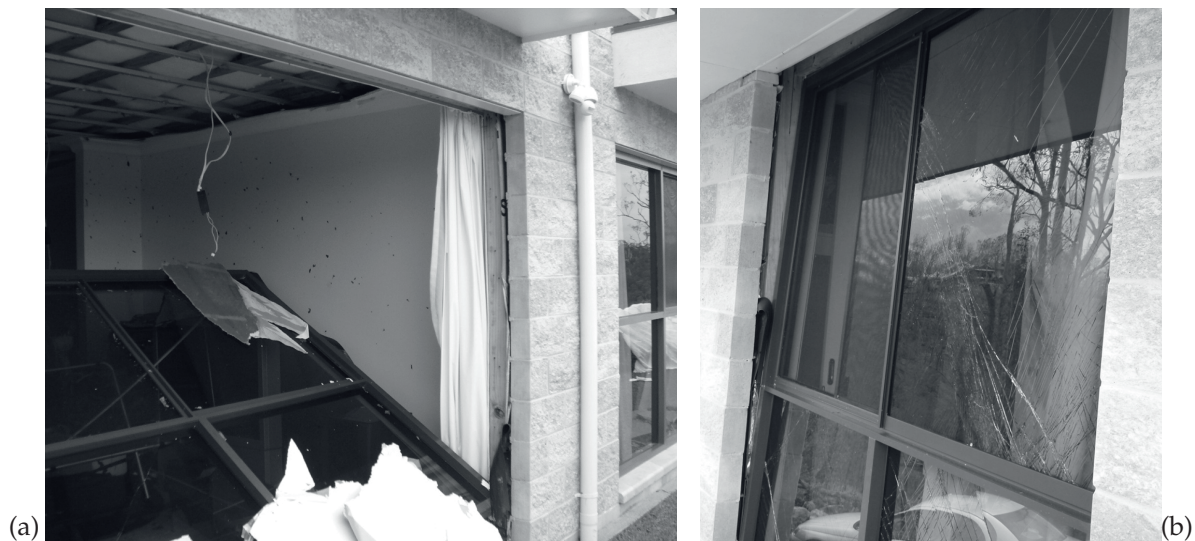
Figure 25: Failure of windward window panels – (a) complete unbroken window pushed in; and (b) window dislodged from jamb studs.

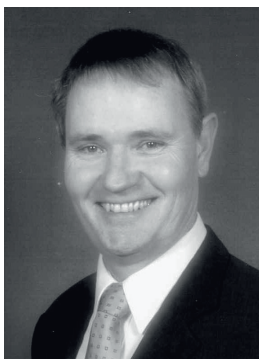
John Ginger is an Associate Professor in Civil Engineering and the Research Director of the Cyclone Testing Station at James Cook University in Townsville. He has been involved in research, testing and consulting in wind engineering since 1987. John has extensive experience in wind tunnel model studies, full-scale field tests and structural vulnerability studies in Australia and overseas. He is a committee member of Standards Australia committees BD-006 – General Design Requirements and Loading on Structures and BD-006/2 – Wind Loads. John is the Chairman of the Australasian Wind Engineering Society. He is the Cyclone Testing Station's representative on the Queensland Tropical Cyclone Consultative committee.

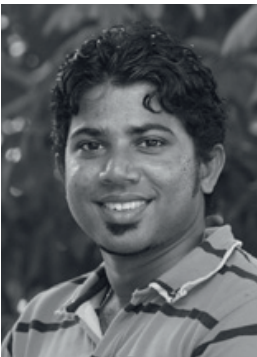
Peter Kim is currently enrolled as a master's student at James Cook University and also working part time as a research engineer with the Cyclone Testing Station. His research focus is on the response of buildings to internal pressures. Peter was previously a full-time research engineer, before joining the Cyclone Testing Station in 2006. He was mainly involved with structural testing, vulnerability models and testing in the Boundary Layer Wind Tunnel. Peter graduated from the University of Western Ontario in Canada with a structural/civil engineering degree. He also spent 16 months as an intern at RWDI in Canada, where he was involved with commercial wind tunnel testing projects for high-rise developments globally.

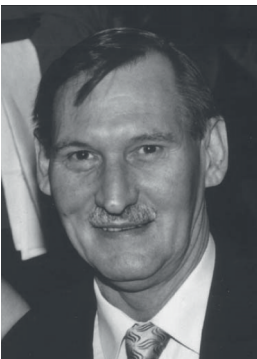
Nandana Jayasinghe is currently a PhD student at James Cook University (since August 2008) and also works with the Cyclone Testing Station, assisting with damage investigations and other projects. His research area is vulnerability of houses subjected to wind loading and the analysis of modes of failure. After graduating from University of Peradeniya, Sri Lanka, he worked as a project engineer at Maldives for one year, and then as a design engineer in a structural design firm in Sri Lanka for two and half years. He was involved in contract administration and project management of most of the projects he designed.
